Campaign for the Preservation of Elijah Kellogg Church

Fact Sheet

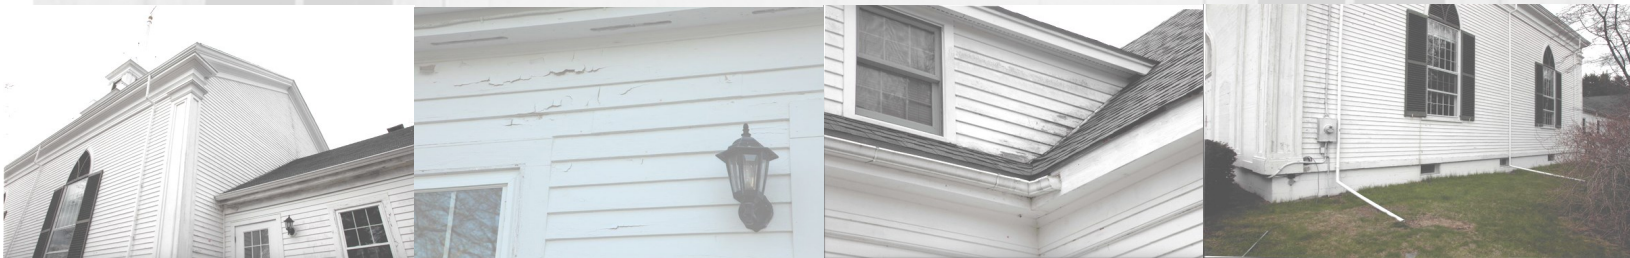
The existing clapboard siding was milled from early growth timber, air dried, and installed with outstanding joinery. Short pieces were necessary to eliminate knots. There is no apparent rot and the original joints are tight. **Properly preserved, the siding is capable of serving the building for another 171 years.**

PAINT

The paint is failing. Since so many coats have been applied, it has lost its resilience and the paint is flaking off and exposing bare wood. **The bare wood will become rotten and major repairs will be necessary.** The paint contains lead and importantly, safety practices will be required to deal with the toxic material. The paint will be removed to bare wood. A primer and two coats of high quality paint will be applied.

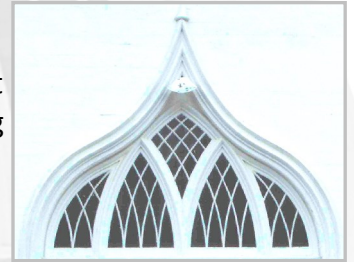
The arched glass window was constructed by Moses Bailey, Master Joiner of West Harpswell. It is a true work of art. It will be **fully restored in place and protected** during the preservation program.

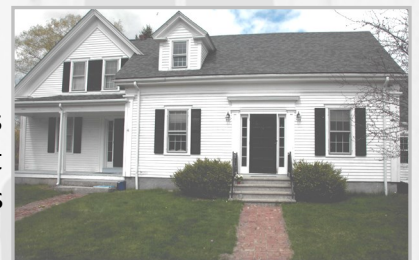
The paint on the siding and trim is failing. Options are being evaluated regarding paint removal and new paint or removal of the existing siding and replacing it with new wooden siding.

The Parsonage is poorly insulated and a major source of heat loss in the winter. It is planned to insulate the attic and the top of the basement walls to meet current energy codes and **realize a measureable reduction** in propane usage. The work is scheduled for the fall of 2014.
